Above the Flood: Elevating Your Floodprone House

FEMA 347/ May 2000

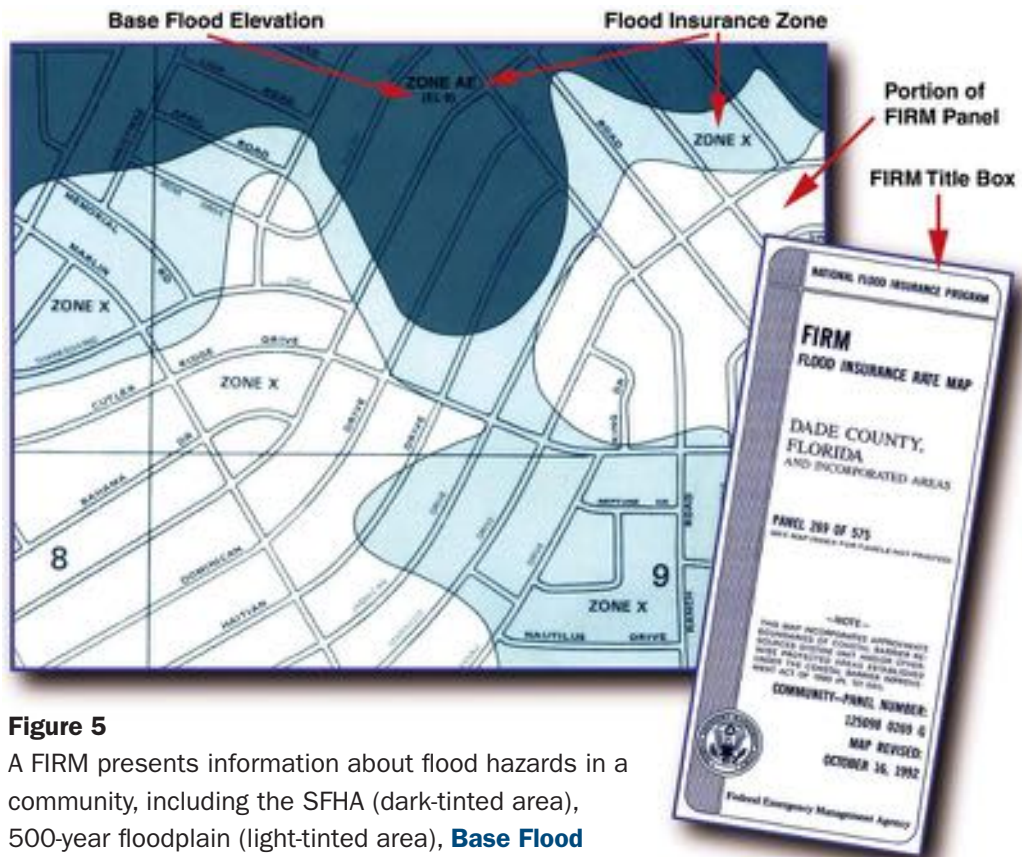
**Figure 5**

A FIRM presents information about flood hazards in a community, including the SFHA (dark-tinted area), 500-year floodplain (light-tinted area), **Base Flood Elevations**, (BFEs) (number in parentheses), and flood insurance zones (AE and X in this example).

Communities participate in the NFIP by enacting and enforcing floodplain management regulations to reduce future flood risks. At a minimum, these regulations govern construction in the **Special Flood Hazard Areas (SFHAs)** shown on Flood Insurance Rate Maps (FIRMs) issued by FEMA (Figure 5).

Note that the SFHA in the example in Figure 5 is designated Zone AE. This zone is only one of several applied to SFHAs under the NFIP, including V, VE, V1-V30, A, AE, A1-A30, AO, and AH. These zones indicate differences in the types and severity of flood hazards in SFHAs. For the purposes of this publication, it is sufficient to focus on the basic differences between the two main types of SFHA zones—V zones and A zones. The distinction is important because regulatory requirements associated with V zones and A zones differ significantly. As explained later in this chapter, these requirements affect the types of building elevation techniques that may be used under the NFIP.

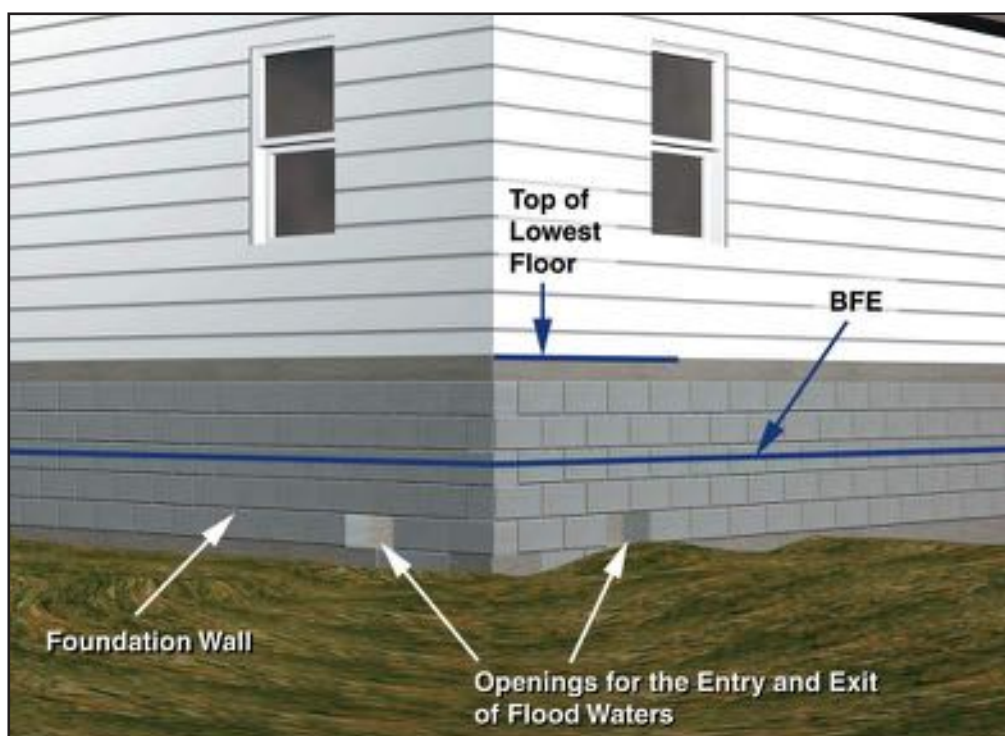
**Figure 6**

In a new, substantially improved, or substantially damaged building in an A zone, the elevation of the lowest floor must be at or above the BFE.

In A zones, where flood hazards are less severe, buildings may be elevated either on an open foundation or on continuous foundation walls below the BFE (Figure 6). Regardless of the type of foundation used, A-zone buildings must be elevated so that the **lowest floor** is at or above the BFE, as shown in Figure 6. If continuous walls are used below the BFE, they must be equipped with openings that allow flood waters to flow into and out of the area enclosed by the walls (Figure 6). Allowing the entry and exit of flood waters ensures that water pressures will be the same on both sides of the walls and reduces the likelihood that water pressure will cause the walls to fail.

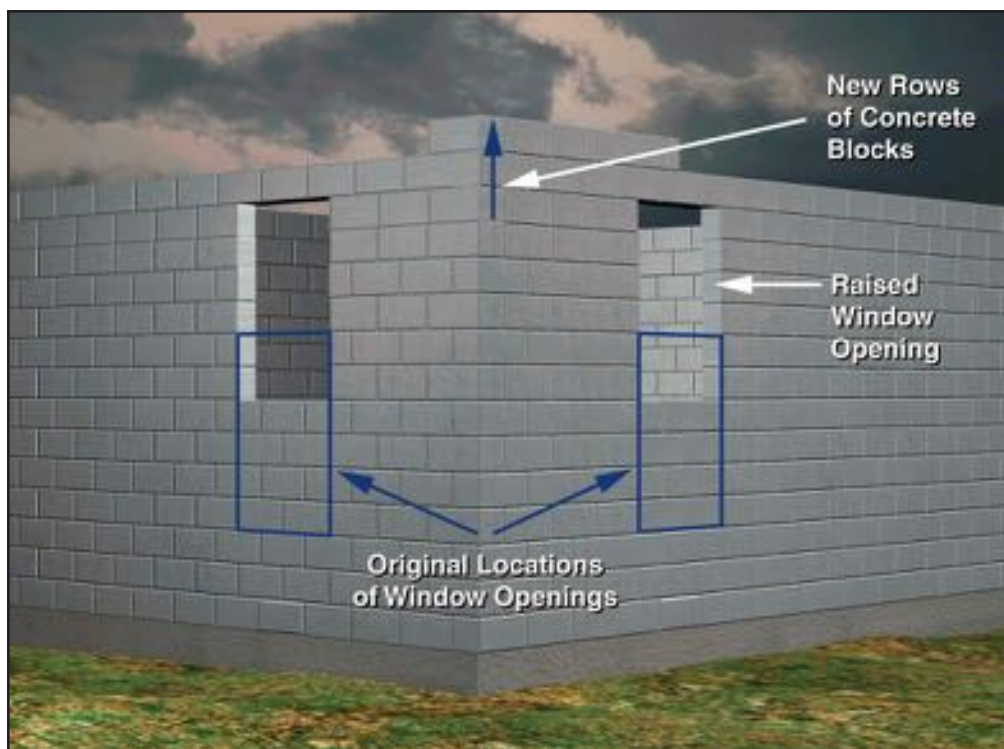
Figure 11

The tops of the walls and bottoms of the window openings are raised with concrete blocks.

After the roof, windows, and doors are removed, several courses of concrete block are added to the tops of the existing walls and to the bottoms of the window openings (Figure 11). A corresponding number of blocks are removed from the tops of the window openings so that the size of the windows will remain the same. In addition, although not shown in Figure 11, concrete bond beams are formed in place at the tops of the extended walls to provide structural reinforcement.

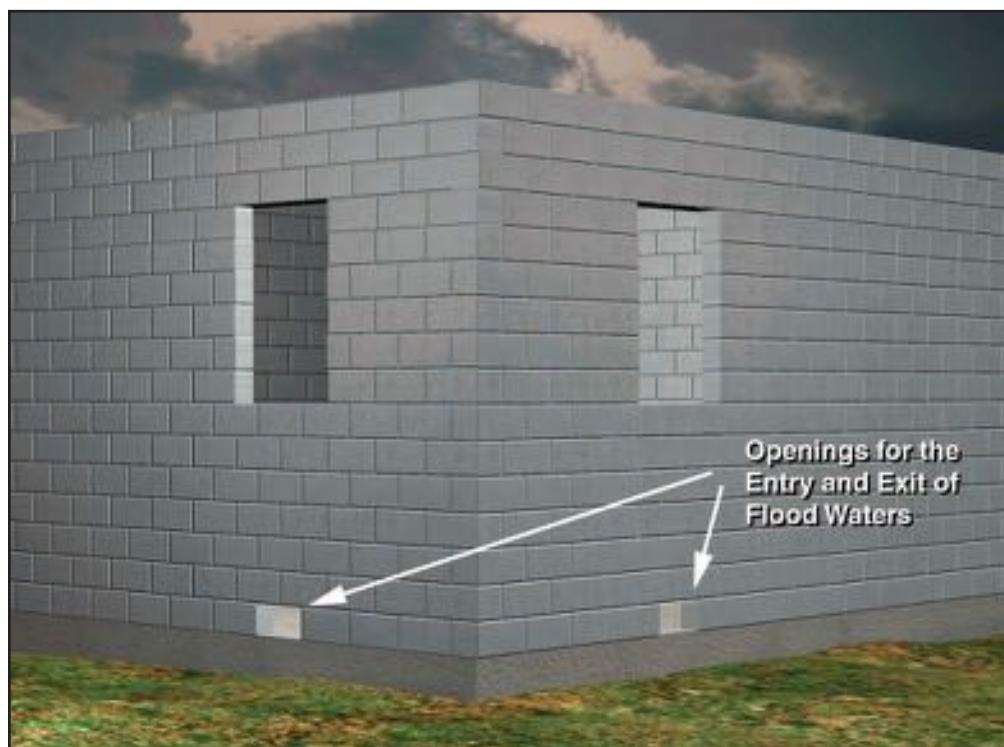
Figure 12
Openings are created in the walls near the ground.

Blocks are removed from the walls of the house at selected locations within 1 foot of the ground (Figure 12). The resulting openings will allow flood waters to flow into and out of the lower area of the house so that the water pressures on both sides of the walls will remain the same. The roof and windows are then replaced, and a new wood-frame floor is constructed above the flood level (Figure 13).

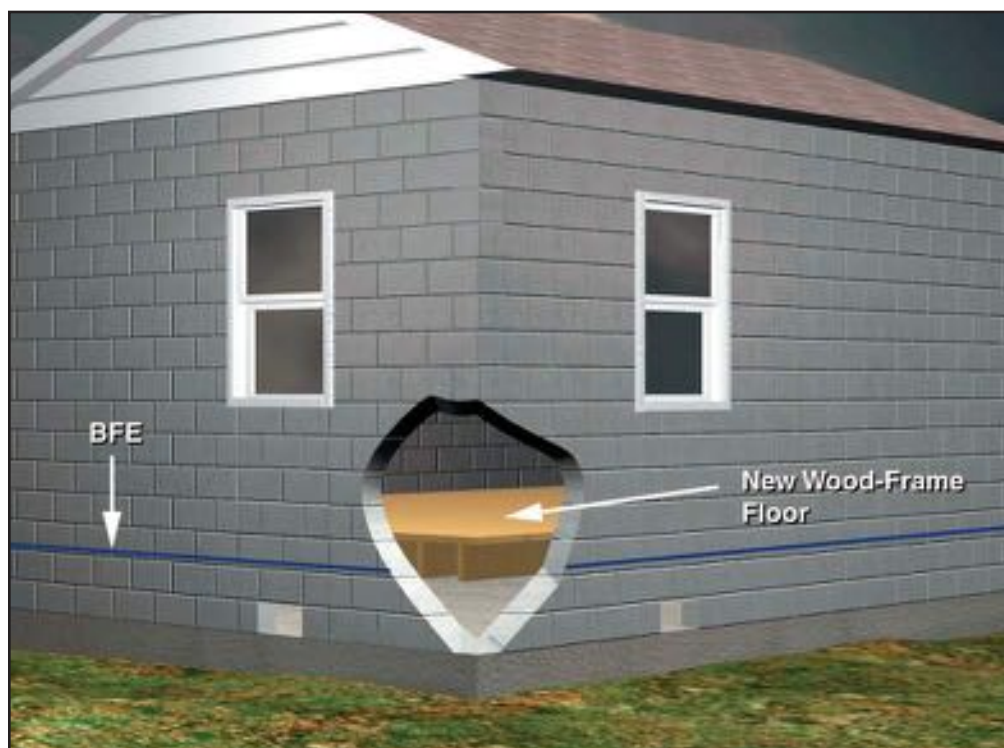
Figure 13
A new wood-frame lowest floor is constructed above the flood level, and the roof, windows, and doors are reinstalled.

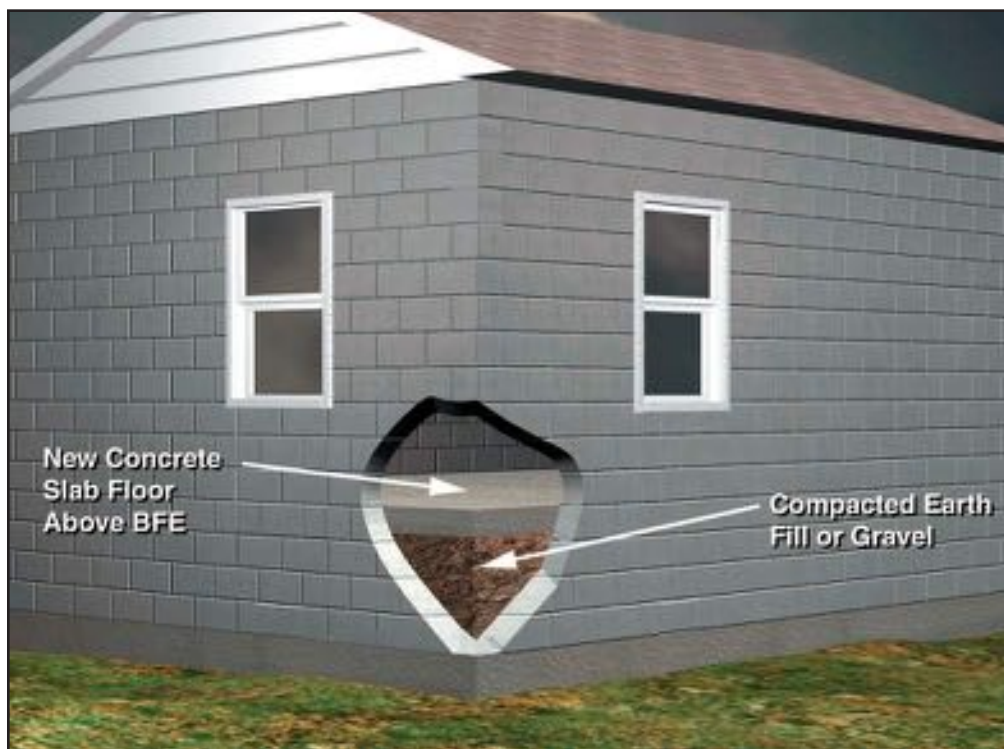
Figure 14
An alternative to building an elevated wood-frame floor is installing a new, elevated concrete slab floor on fill placed over the old slab.

A homeowner who chooses Technique 1 may decide to build a new concrete slab floor instead of a wood floor (Figure 14). When this option is chosen, compacted fill dirt or gravel is placed on top of the old slab and the new slab floor is poured on top. Because the area below the new floor is filled with dirt or gravel, wall openings are not required.

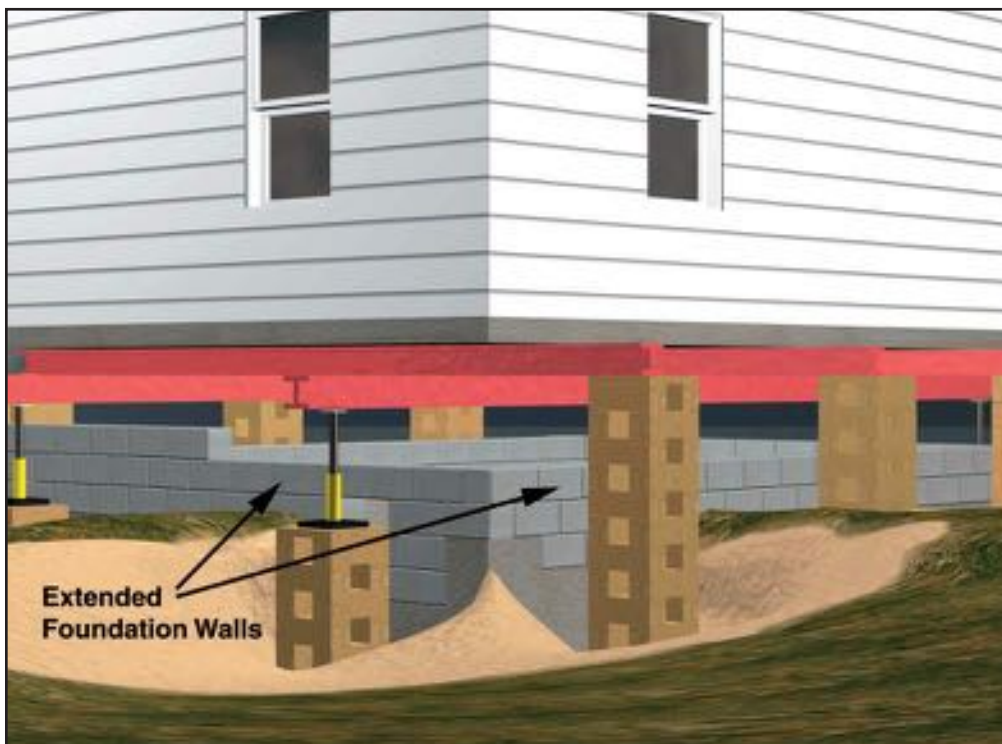
Figure 19
The house is temporarily supported on cribbing.

The house is then jacked up. When the jacks have extended as far as possible, the house must be supported temporarily while the jacks are raised. Both the house and the jacks are usually supported on “cribbing”—temporary piles of crisscrossed timbers (Figure 19). The jacks are then used to raise the house higher.

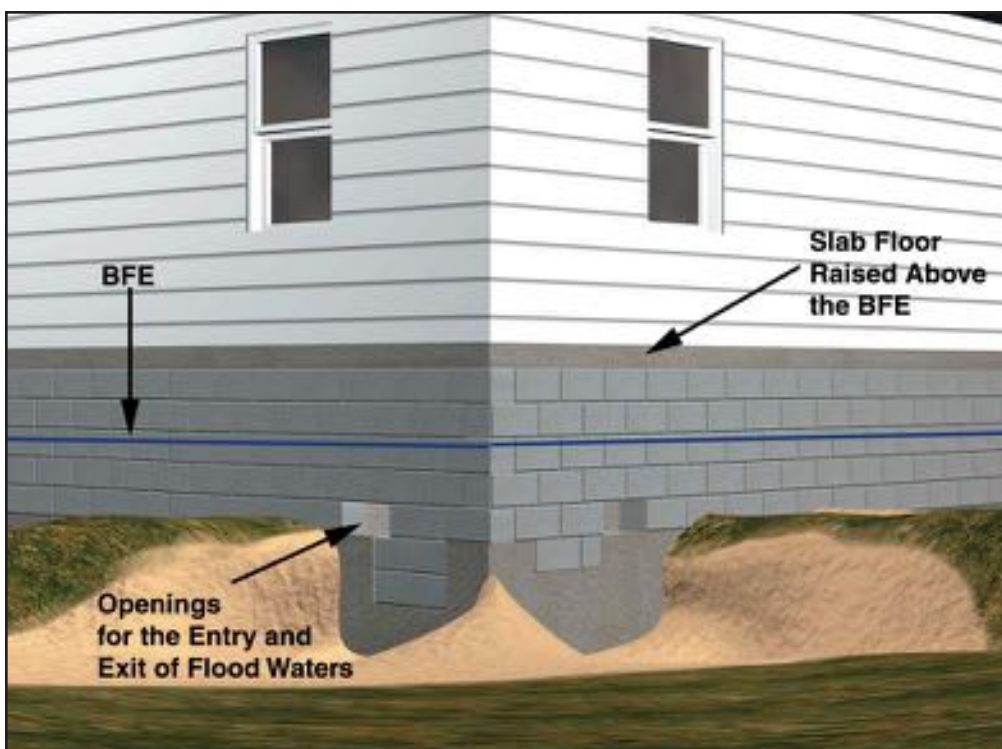
Figure 20
New, extended
foundation walls are
constructed with
concrete blocks.

This process is repeated until the house is raised to the desired height. The foundation walls are then extended upward with additional rows of concrete block (Figure 20). As in the previous techniques, openings are made in the walls within 1 foot of the ground so that flood waters will be able to flow into and out of the area below the elevated floor. The jacks and beams are removed, and the openings left around the beams are filled with blocks (Figure 21).

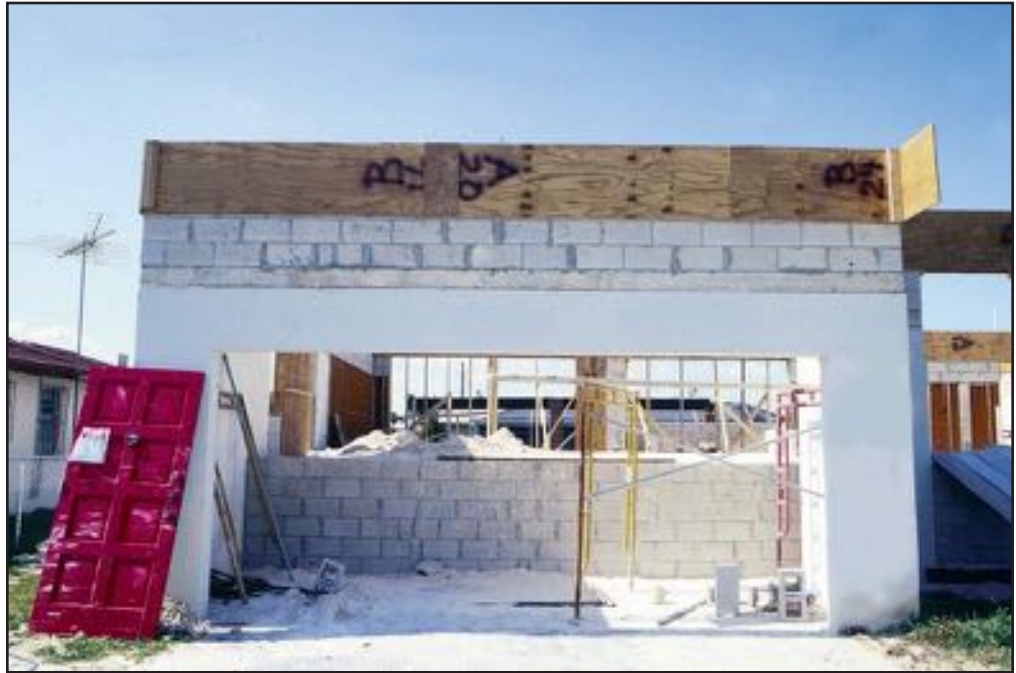
Figure 25

This view through the garage door reveals the different levels of the elevated slab floor, in the background, and the unelevated garage floor.

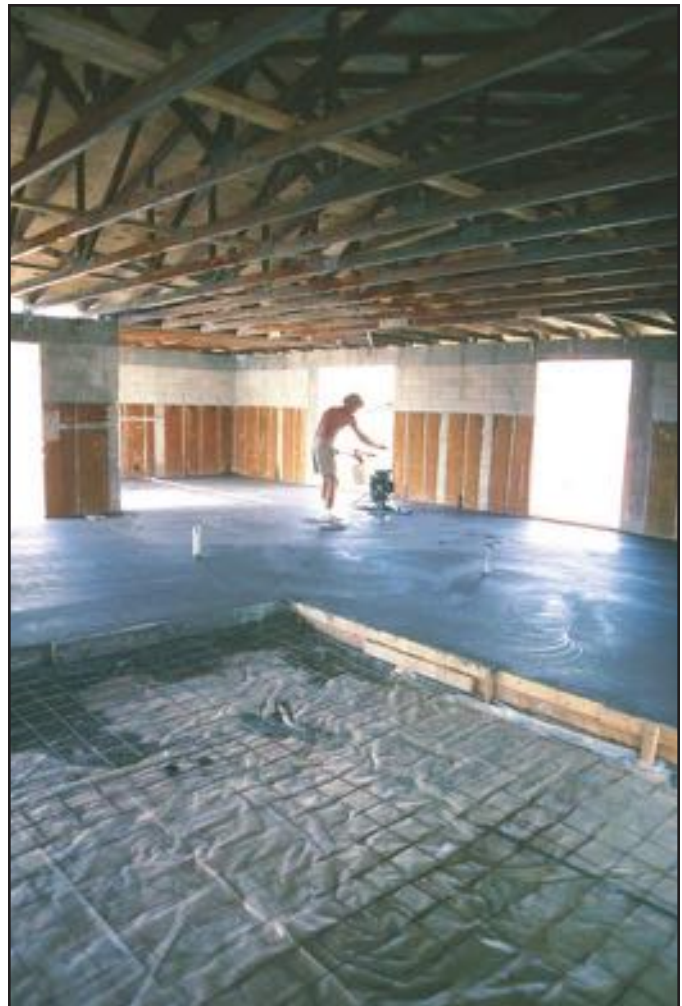
**Figure 26**

The roof has been rebuilt with the salvaged trusses, and most of the new concrete slab has been poured on top of the sand fill. The open area in the foreground, where plastic sheeting and wire reinforcement can be seen on top of the sand fill, is where the remaining part of the slab will be poured.

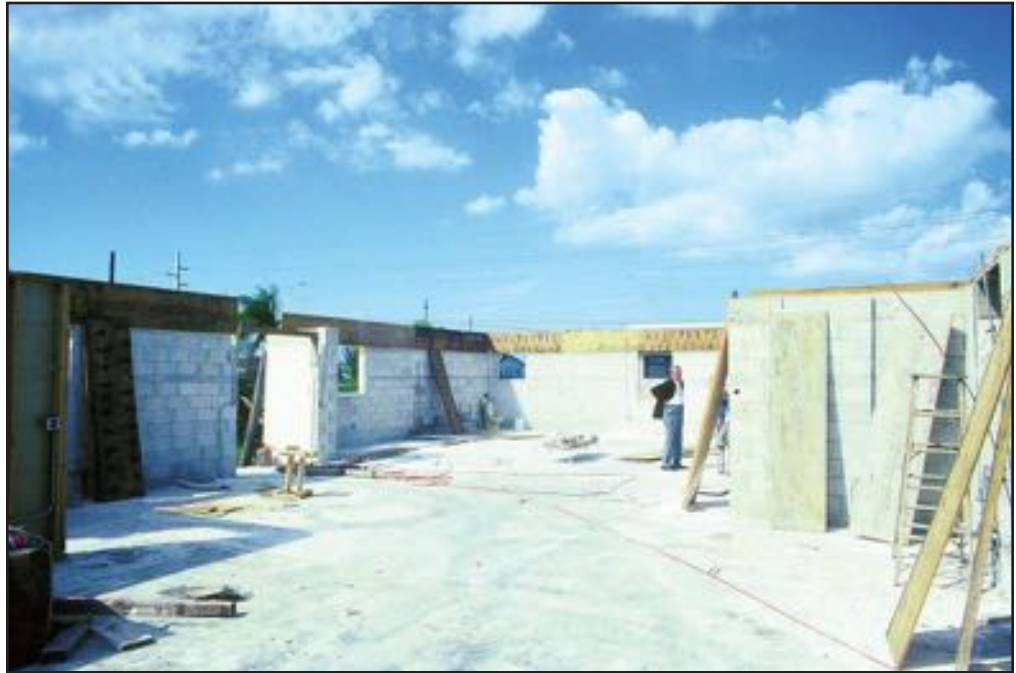
Figure 40

After the roof was removed and the storm-damaged interior gutted, the walls of the house were extended upward and a new bond beam added at the top.

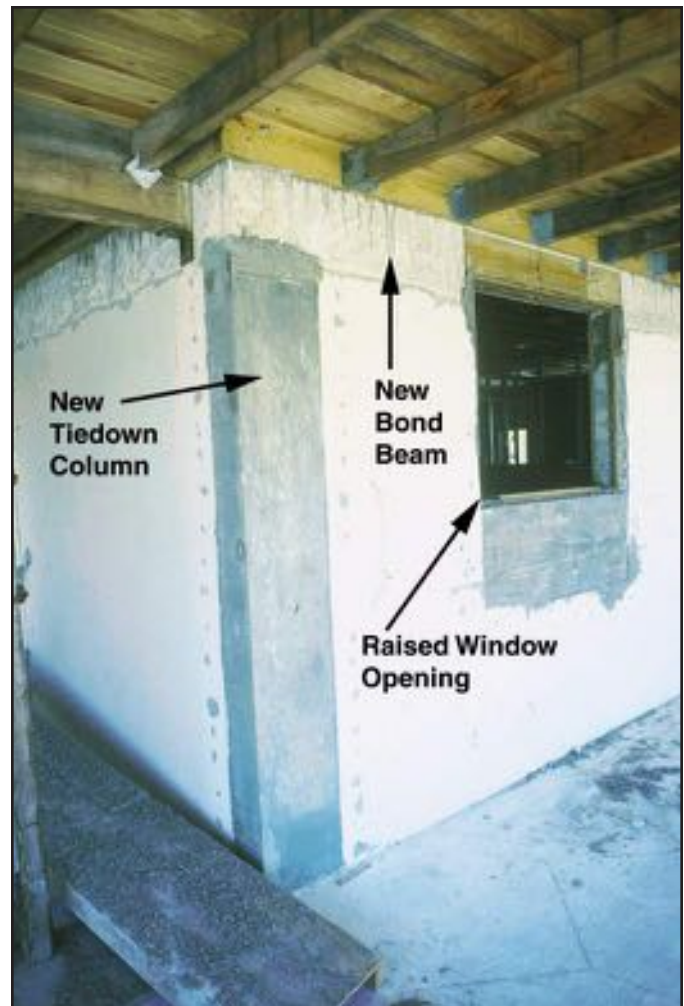
**Figure 41**

Note the new bond beam at the top of the extended wall, the new concrete tiedown column at the corner, and the raised window opening.

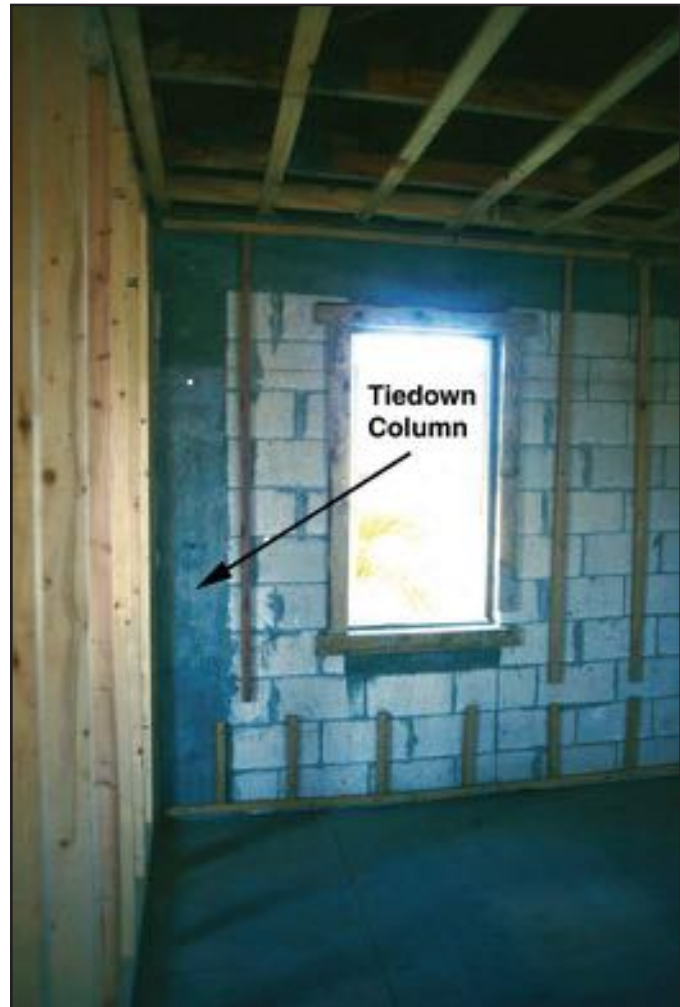
Figure 46
Concrete tiedown columns, such as the one to the left of the window in this photograph, were also used in this house.

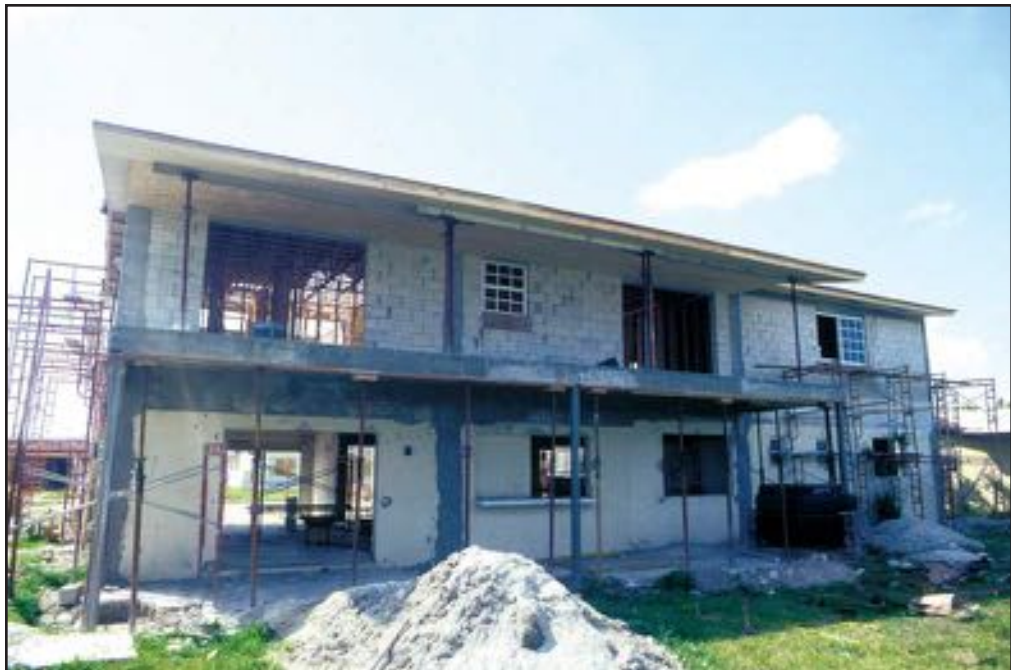
Figure 47
The tiedown columns extend down from the new second-story walls and into the original first-floor walls. The columns tie the first and second stories together and provide a continuous load path that helps the house resist the forces of high winds.

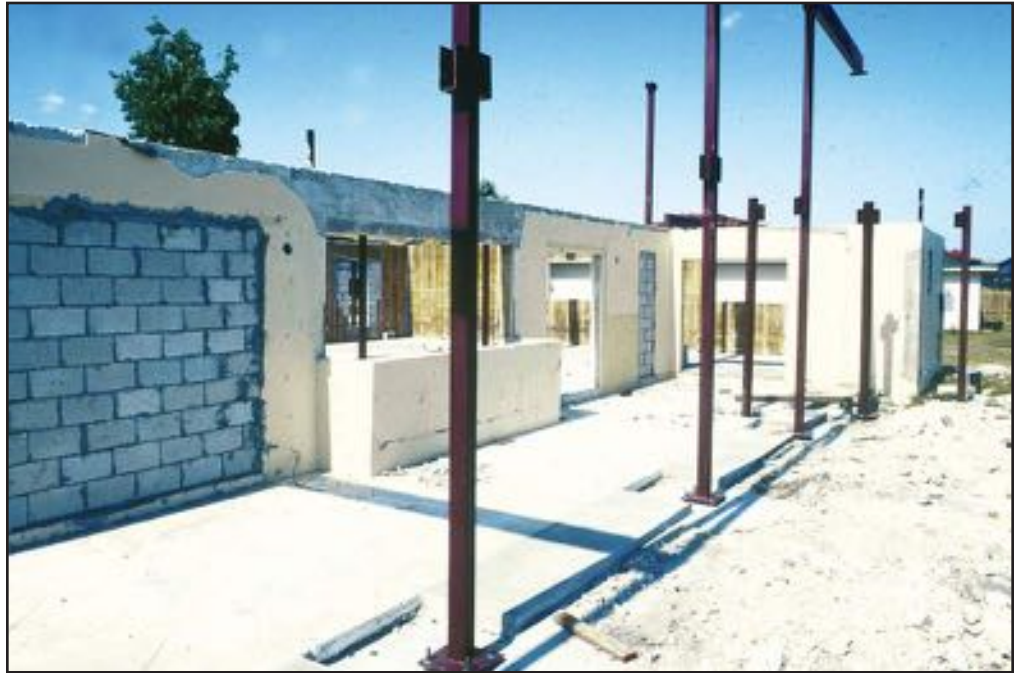
Figure 52

The existing first-story walls have been strengthened by the addition of concrete block. Metal columns and beams have been added to help support the new second story.

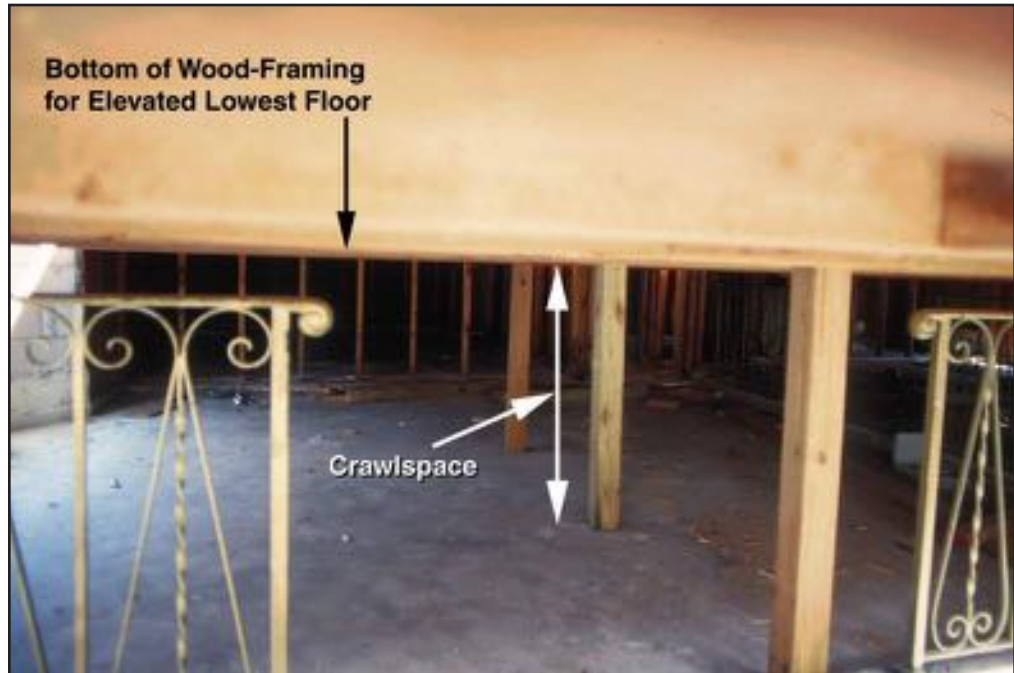
Figure 68

Rather than install a new concrete slab on compacted fill, the owner of this house chose to build a new wood-frame floor above the old concrete slab. This method creates a crawlspace below the new floor.

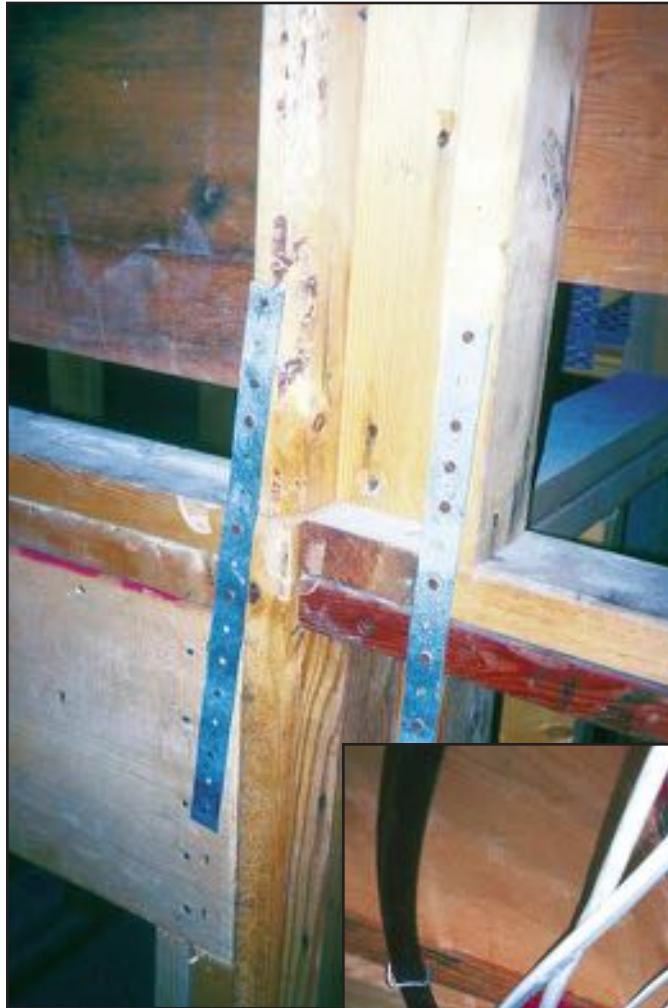
Figure 70

Metal hurricane straps are used to tie the structural members together and create a continuous load path from the roof to the foundation.

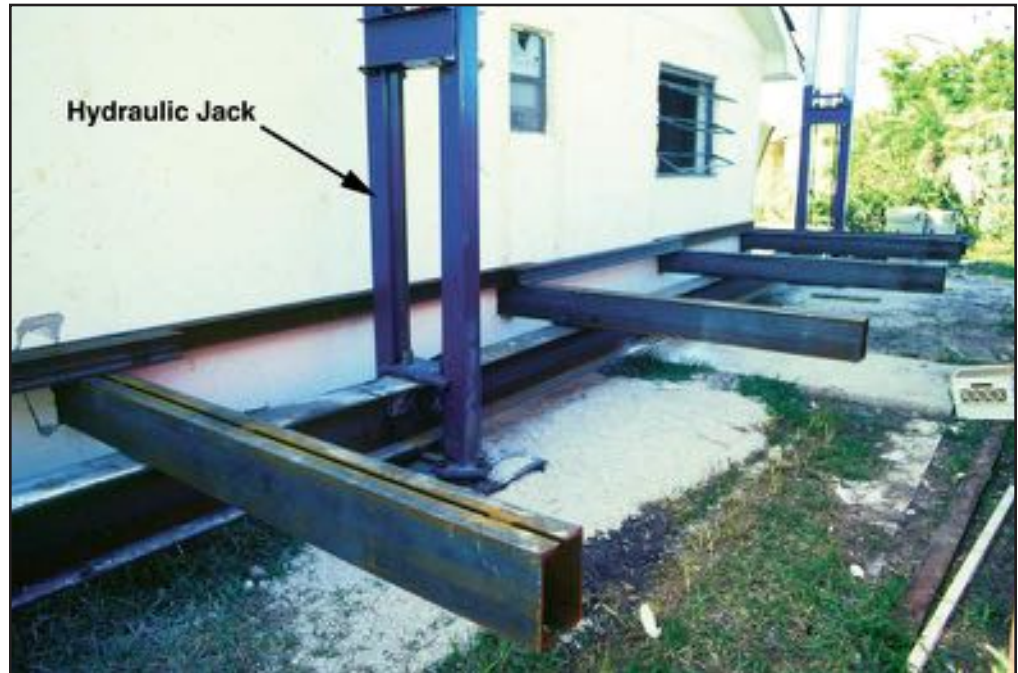
Figure 74

In this variation of Technique 3, steel beams are inserted through the walls of the house rather than under the slab. The beams span the length and width of the house and cross one another inside to create a grid. Outside the house, the beams rest on larger beams that will be raised with hydraulic jacks.

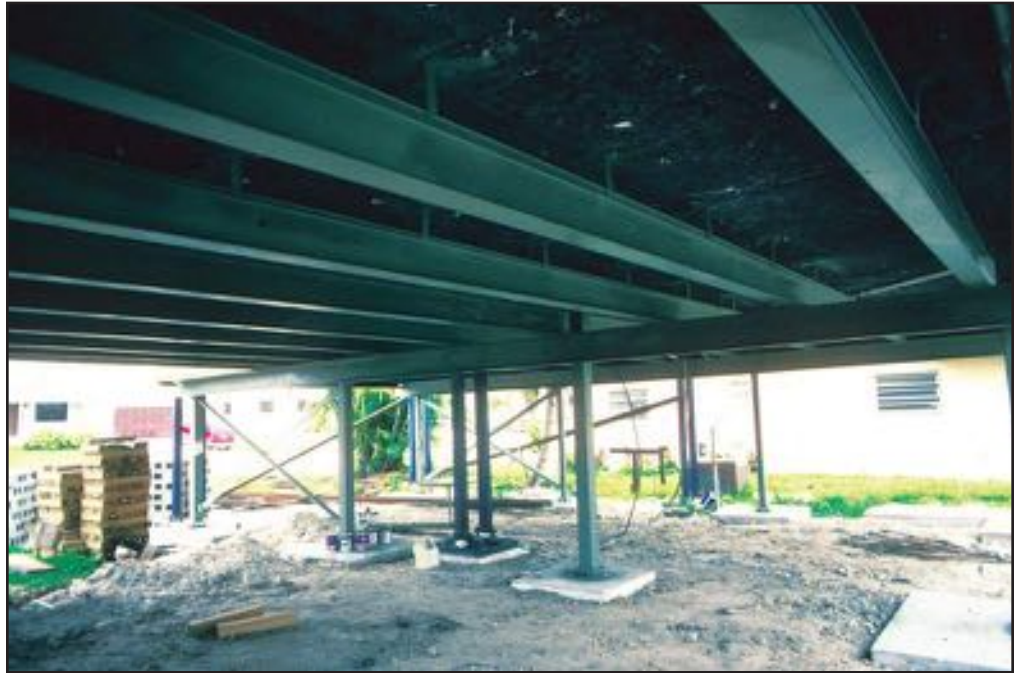
Figure 82

While the jacks and beams supported the house, new steel foundation members were installed below.
