APALACHICOLA REGIONAL AIRPORT AIRPORT MASTER PLAN UPDATE

WORKING PAPER NUMBER TWO

Chapter 4: Environmental Considerations

Chapter 5: Facility Requirements

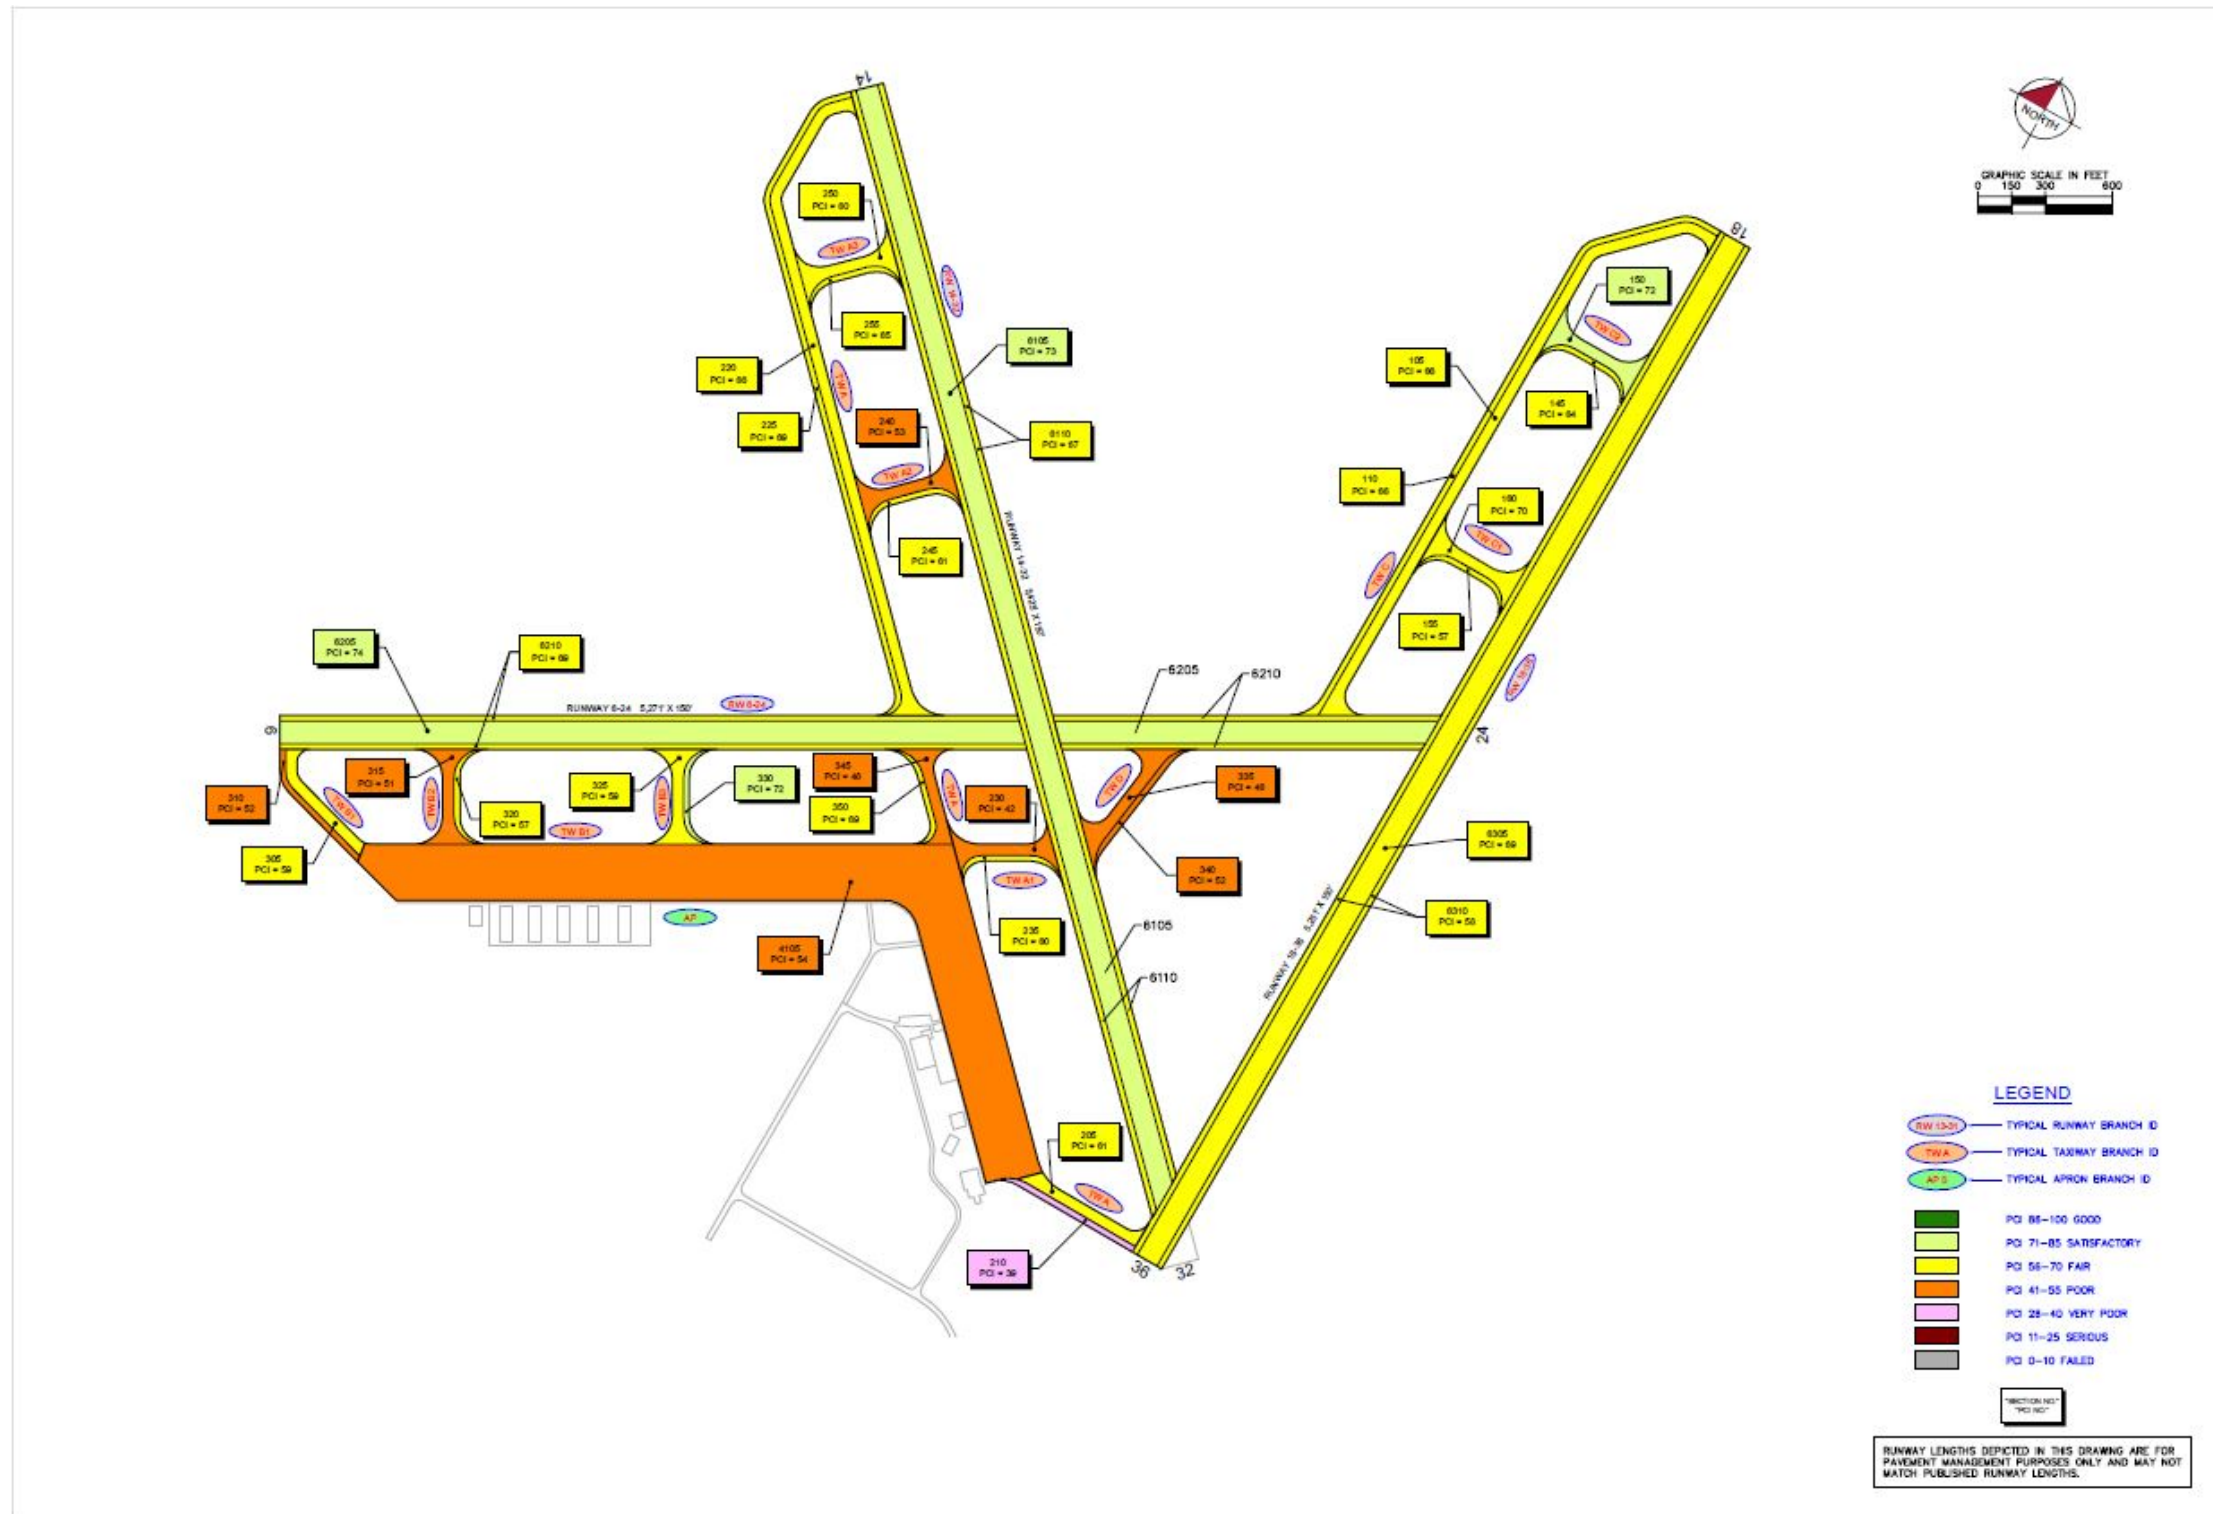
Figure 5-2
AIRFIELD PAVEMENT CONDITIONS MAP

Source: Statewide Airfield Pavement Management Program, September 2017

All the runways are constructed of concrete, with varying levels of condition. Table 5-16 shows a portion of the airfield pavement conditions inventory. A graphic from the 2017 FDOT PCI Report for the Airport is shown as Figure 5-2.

330	Taxiway B3	72	Satisfactory	10,600	PCC	1942
335	Taxiway D	46	Poor	15,082	PCC	1942
345	Taxiway A	48	Poor	29,764	PCC	n/a
350	Taxiway A	69	Fair	10,975	PCC	n/a
4105	Apron	54	Poor	979,973	PCC	1940
6105	Runway 14/32	73	Satisfactory	512,205	PCC	1940
6110	Runway 14/32	67	Fair	256,102	PCC	1940
6205	Runway 6/24	74	Satisfactory	498,541	PCC	1940
6210	Runway 6/24	69	Fair	249,271	PCC	1940
6305	Runway 18/36	69	Fair	525,250	PCC	1940
6310	Runway 18/36	58	Fair	262,625	PCC	1940
